NATIONAL BUREAU OF STANDARDS REPORT

**CONTROL OF LEAKAGE THROUGH JOINTS
IN CAST-STONE MASONRY AT
THE NATIONAL NAVAL MEDICAL CENTER**

**Progress Report No. 1
by
A. Hockman, E. J. McCamley and
E. W. Krussell**

**To
District Public Works Office
Potomac River Naval Command
Bureau of Yards & Docks
Department of the Navy**

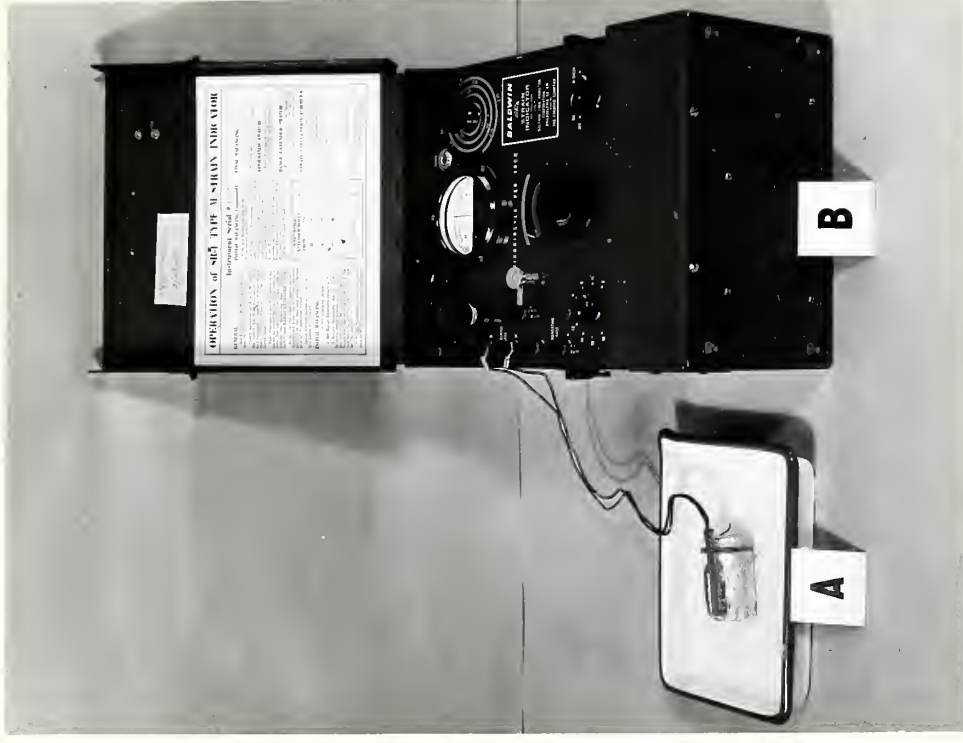
Fig. 4. Moisture expansion test (A) Modified resistance strain gage cemented to cast-stone. (B) Strain indicator

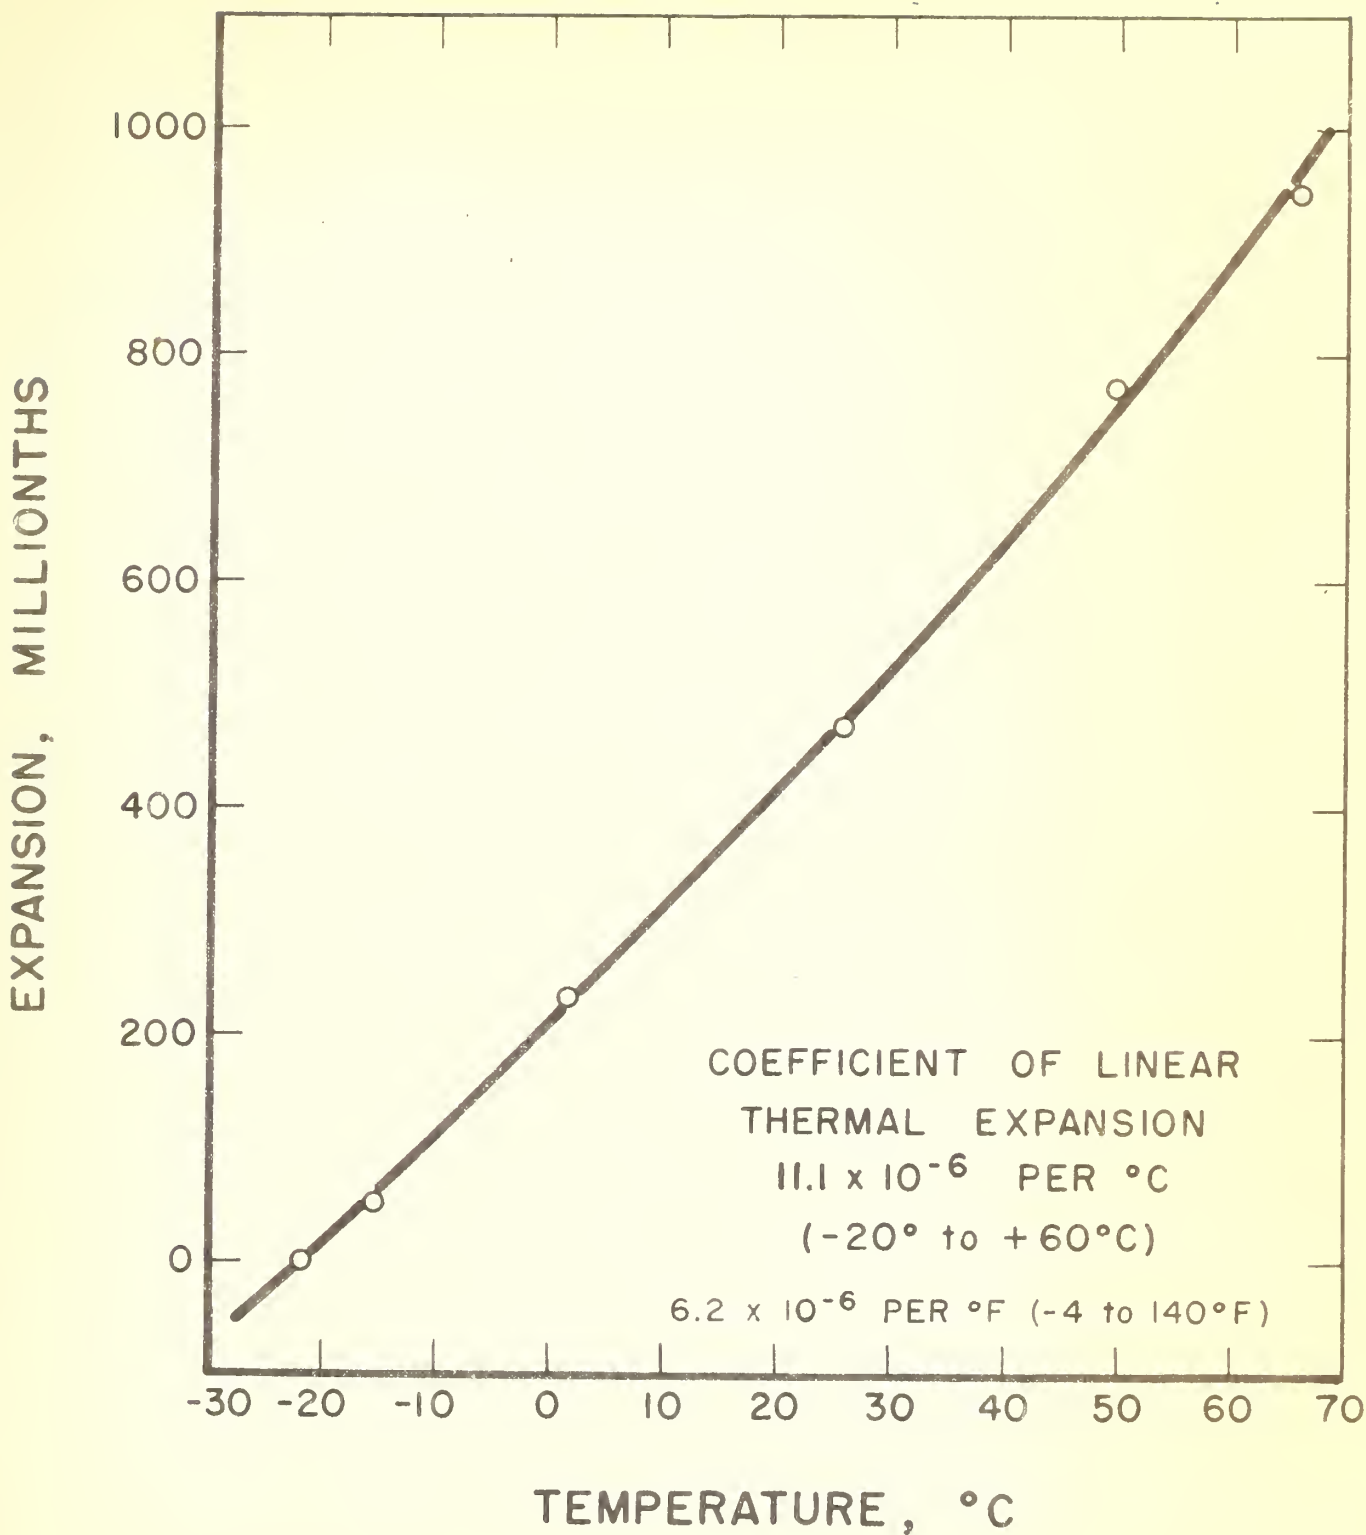
FIGURE NO. 5 THERMAL EXPANSION CURVE OF SAMPLE OF CAST STONE USED AT THE NAVAL MEDICAL CENTER.

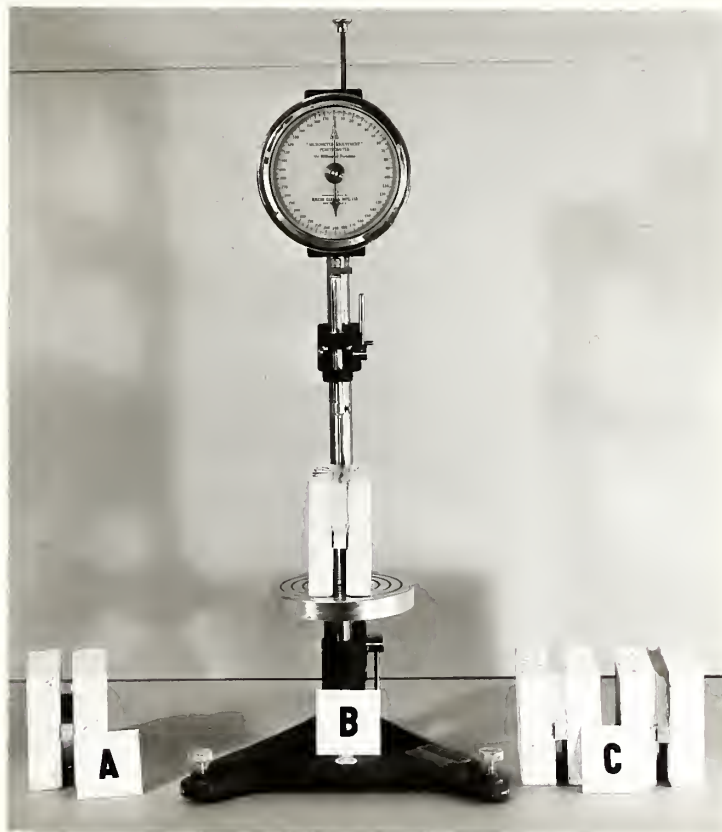
This property is determined by means of a brass ring $2\ 5/8$ in. in diameter and $1/2$ in. high (volume, V , known to .01 ml), a ground glass cover plate and a slab of cast-stone, $3\ 1/2$ by $3\ 1/2$ by 1 in. (see figure 8-C,D). After the combined weight of the ring, slab and cover plate is determined, the ring is centered on the slab, $1/8$ in. layer of compound is spread inside the ring, in firm contact with the stone and a weight determined (W_2). The ring is then filled over the calking with distilled water and a third weight determined (W_3). Since the volume of 1 gram of water is approximately 1 ml, the volume of the layer of calking, $V_c = V - (W_3 - W_2)$. The water is then poured off and the sample exposed at room temperature for 15 days, after which W_2' and W_3' corresponding to W_2 and W_3 are determined. The final shrinkage is calculated as follows:

After the brass ring is removed from the shrinkage test specimen, half of the calking layer is loosened from the stone and is folded over the remaining part and creased six times along the same line (see figure 8-E). Embrittlement or lack of tenacity can be observed. This test is also being made at below freezing temperatures.

A metal trough 4 in. long, 1 in. deep and $3/8$ in. wide is filled with the compound and suspended for 24 hours at room temperature, followed by a similar test at 122°F (figure 8-B). The material is observed for flow tendencies. Slump tests are also being made in cast-stone grooves.

Fig. 8. Calking test specimens
(A) Test specimens used for plasticity and bond studies at cold temperatures, (B) consistency test specimens, (C,D) shrinkage test specimens, (E) tenacity test specimen.

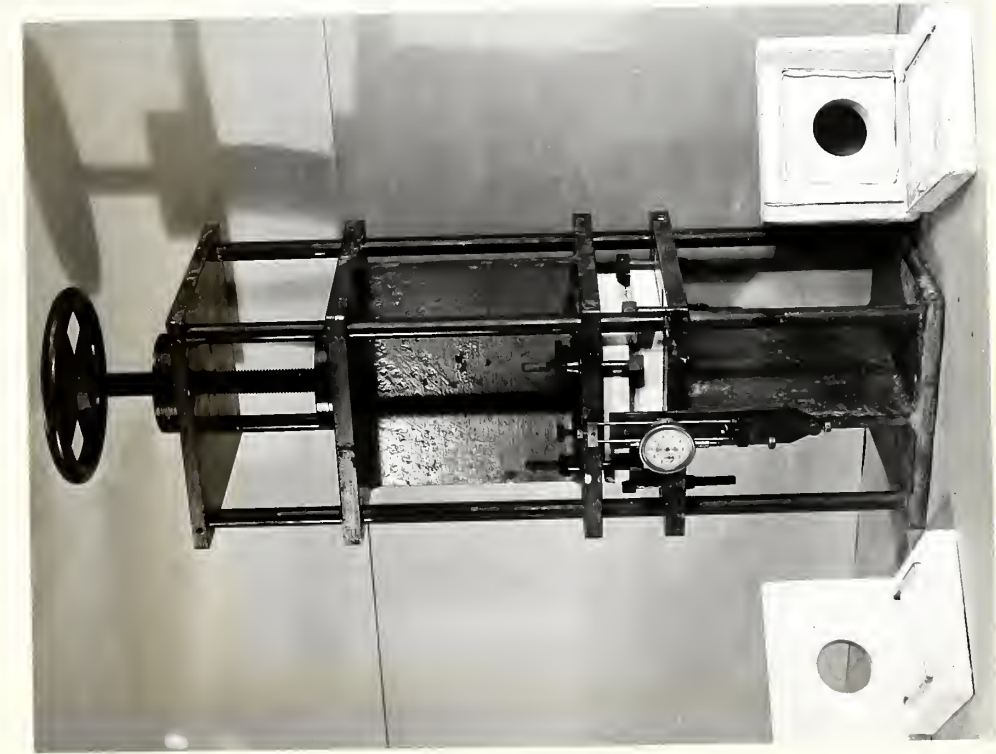
The apparatus used to make this test is described in Federal Specification SS-R-406c, No. 223.11, for testing asphalt joint sealers. Two cast-stone blocks, forming a joint 2 x 2 x 3/8 in. is filled with calking and allowed to cure for 30 days at room temperature. After the test specimen is placed in a cold box for at least 4 hours, it is clamped into place in the stretching machine, and the blocks drawn apart at the rate of 1/8 in. per hour until the joint is extended 1/10 in. (figure 11). During the test the temperature is maintained at 0°F. Observations are made of the bond and plasticity properties.

Fig. 11. Bond and plasticity test at 0° F. Calking test specimen is shown in place between two clamps ready for test.

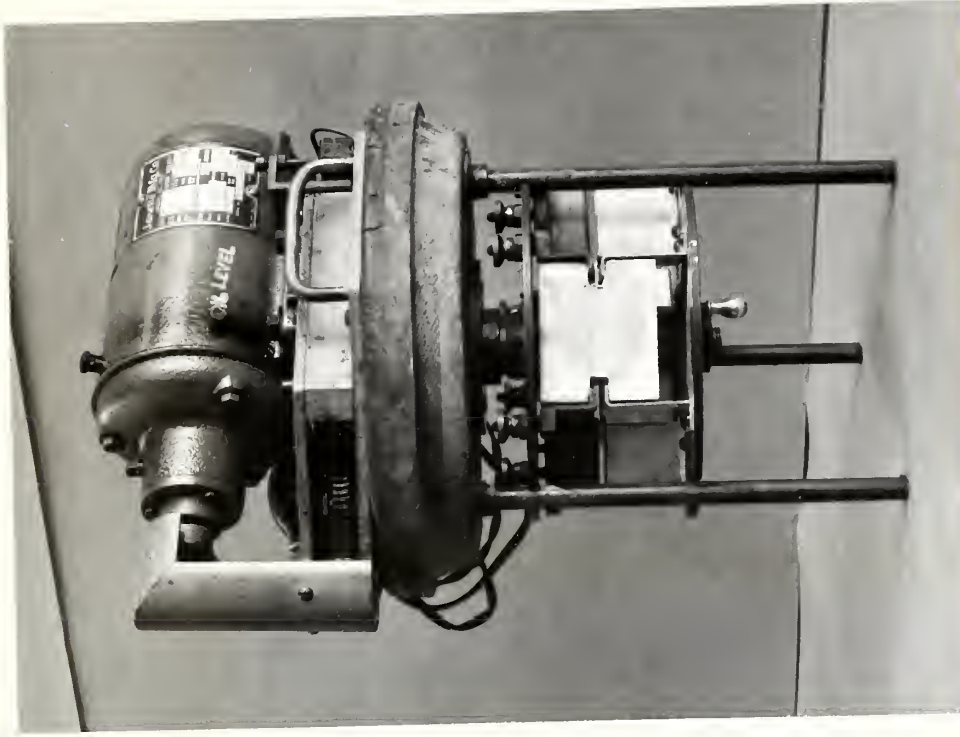
The joint tested is made between two slabs of cast-stone, 6 by 7 by 1 in., one of which has a 2 1/2 in. round hole. Calking is placed between slabs which are held apart by a 1/4 in. brass spacer, making a joint 1/4 in. thick and 3/4 in. deep on all four sides of the stone. (Figure 10). After 30 days of curing at room temperature, the slabs are drawn apart by a special apparatus (figure 10), the amount of separation being measured by a 0.001 in. micrometer dial gage. At the start of the test, water is poured into the hole of the top block and the joint is watched for leakage as the blocks are drawn apart. Figure 10, right, shows a compound after test in which premature failure was caused by lack of bond.

Fig. 10. Bond and plasticity test at room temperature. Left, cast-stone blocks before calking is applied. Center, calking under test. Right, example of failure of calking due to lack of bond.

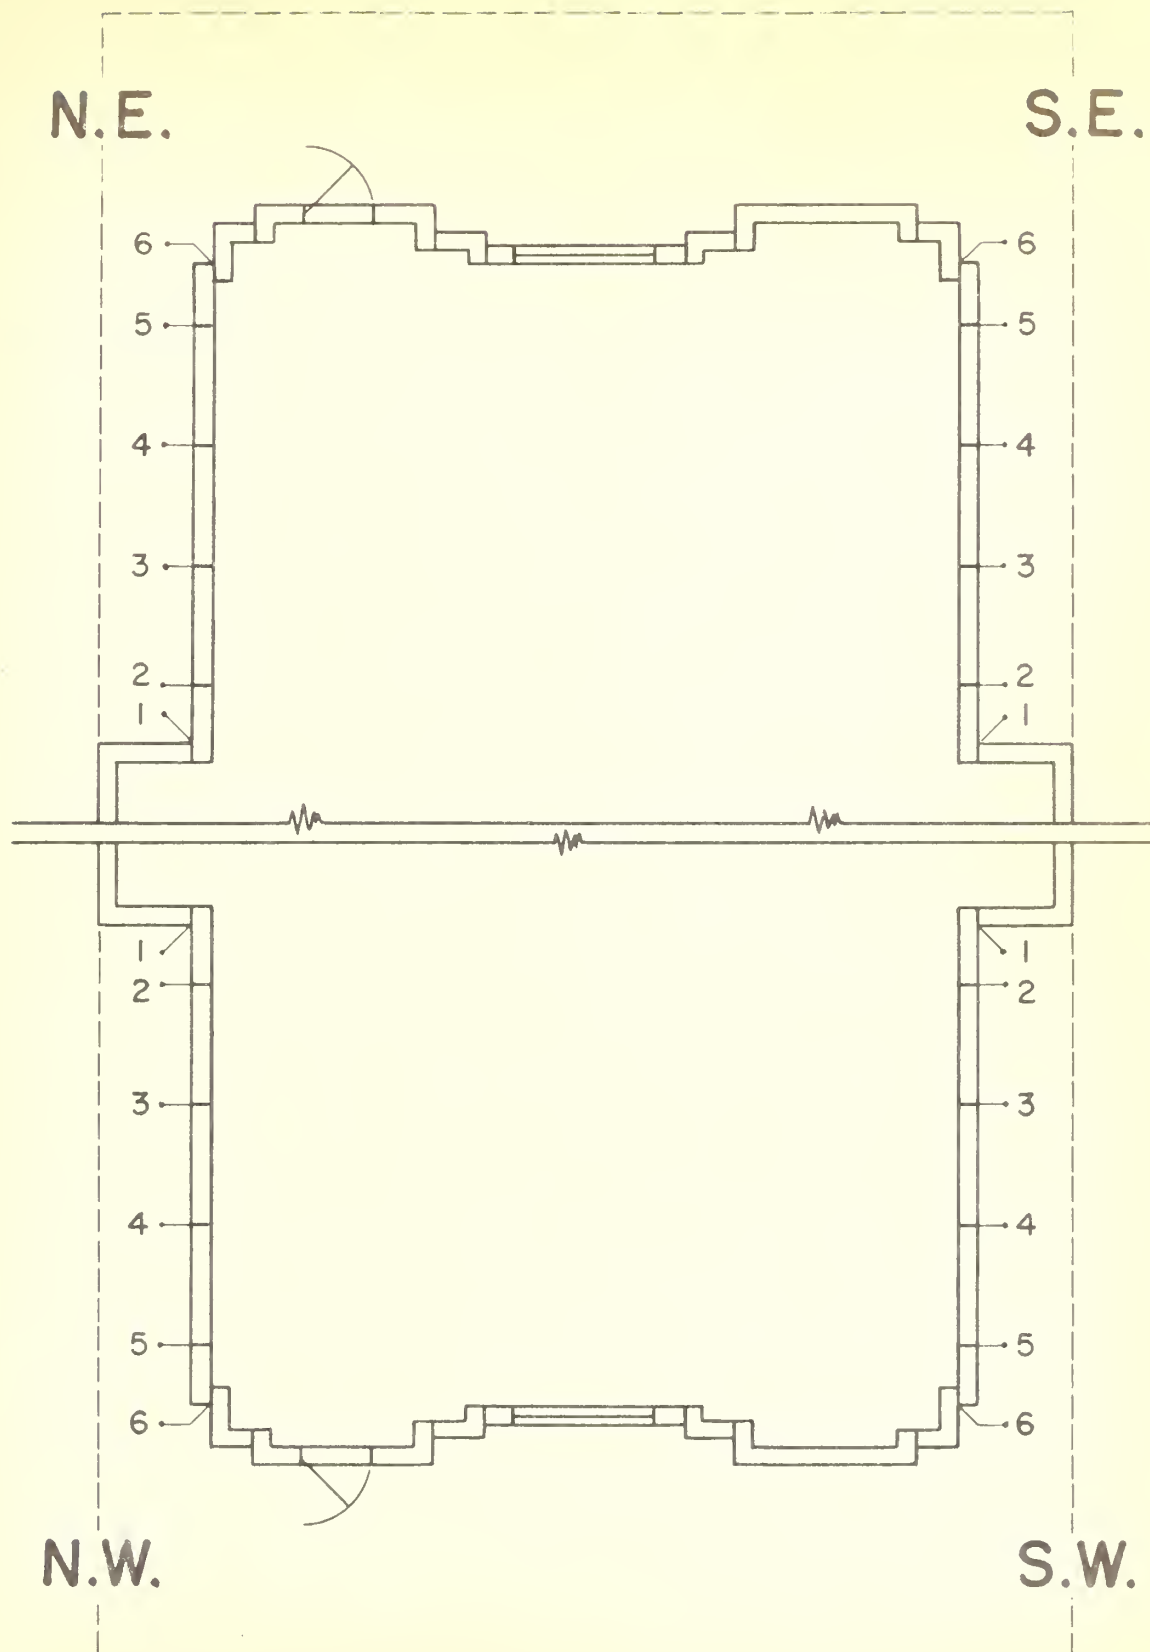
Figures 13 and 14 give the exact locations of the gage stations installed in the cast-stone panels on the northeast, northwest, se and sw elevations. At the start of the investigation, six stations were installed at each elevation in such manner that each station straddled a vertical joint at the 4 1/2 ft. level. Stations Nos. 1 and 6 were installed for measurement of panel movements in corners. After many unsuccessful attempts were made to obtain dependable and accurate measurements of the corner joint movements, it was decided to abandon the corner stations and restrict the measurements to stations 2, 3, 4, and 5, on all four sides of the building.

FIGURE NO. 13 PLAN VIEW SHOWING LOCATION OF ALL GAGE STATIONS
USED IN MEASUREMENT OF JOINT MOVEMENTS.
(19TH FLOOR LEVEL, BUILDING NO. 1, NAVAL MEDICAL
CENTER.)

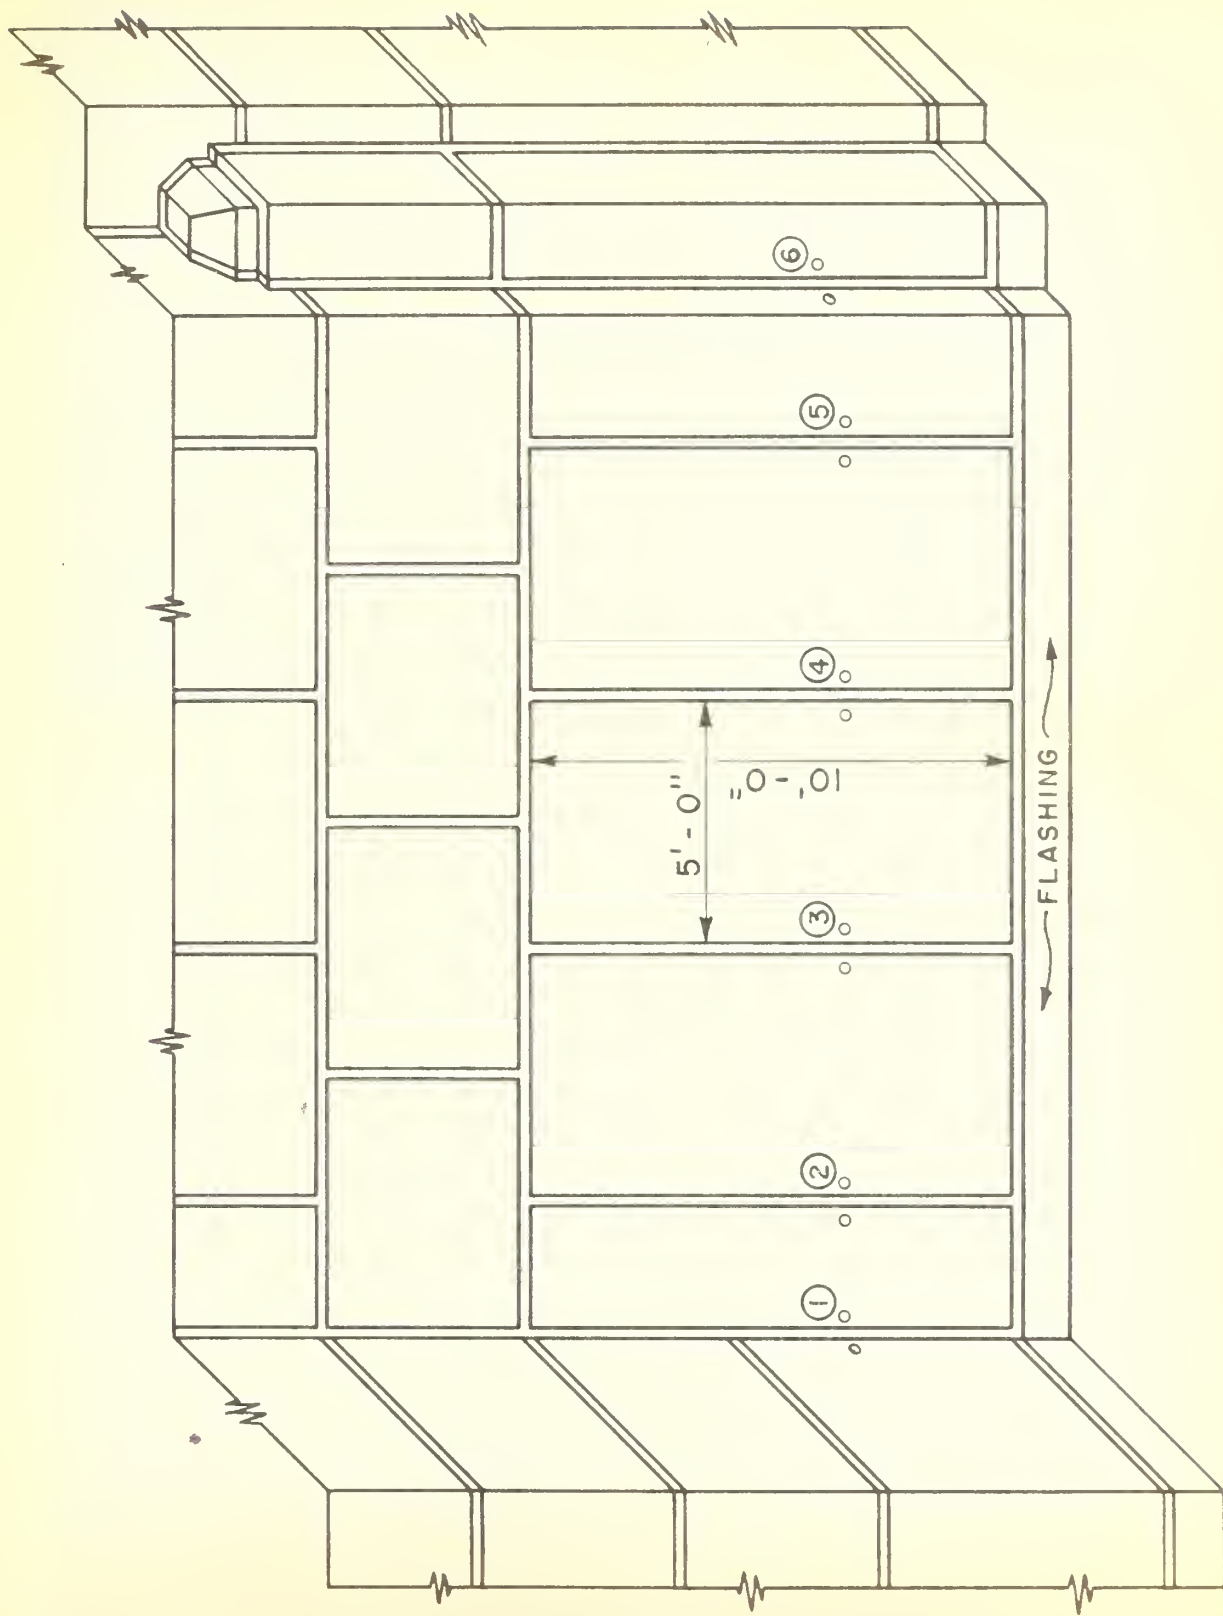
FIGURE NO. 14 TYPICAL WALL ELEVATION SHOWING LOCATION OF ONE SET OF GAGE STATIONS USED IN MEASUREMENT OF JOINT MOVEMENTS. (19TH FLOOR LEVEL, BUILDING NO. 1, NAVAL MEDICAL CENTER.)

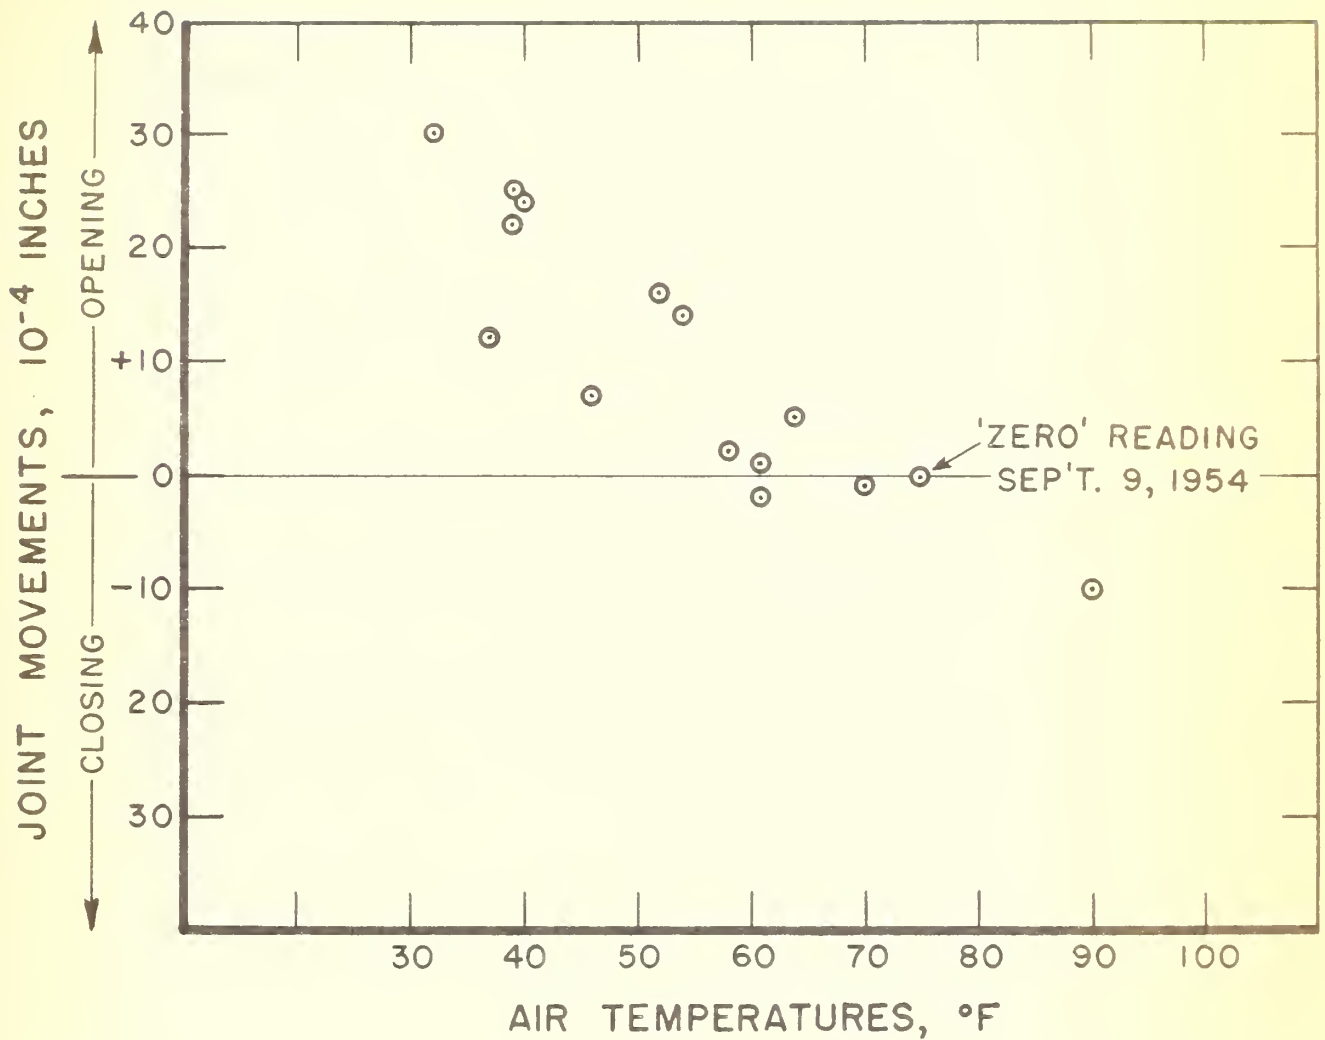
Figure 16 and table 3 give the complete record of joint movements as measured at all 16 gage stations on 15 separate occasions from September 9 to April 27, 1955. In general, the joint movements were directly related to the changes in temperature. A rise in temperature caused the cast-stone panels to expand which resulted in a closing or contraction of the joints. This is illustrated by the September 29 readings, when the temperature rose to 90°F and the joints contracted in most instances (cast-stone panels expanded). Similarly, a drop in temperature to 39°F on December 4, 1954, caused most of the joints to open or expand (cast-stone panels contracted). Figure 17 shows the correlation between the joint movements and the air temperature recorded at the time of gage readings.

FIGURE NO. 17 RELATIONSHIP BETWEEN JOINT MOVEMENTS AND AIR TEMPERATURES RECORDED AT THE TIME GAGE READINGS WERE TAKEN. EACH POINT REPRESENTS THE AVERAGE DATA OBTAINED ON EACH OF THE 15 DAYS THAT MEASUREMENTS WERE MADE FROM SEP'T. '54 THROUGH APRIL '55. (19TH FLOOR LEVEL, BUILDING NO. 1, NAVAL MEDICAL CENTER.)

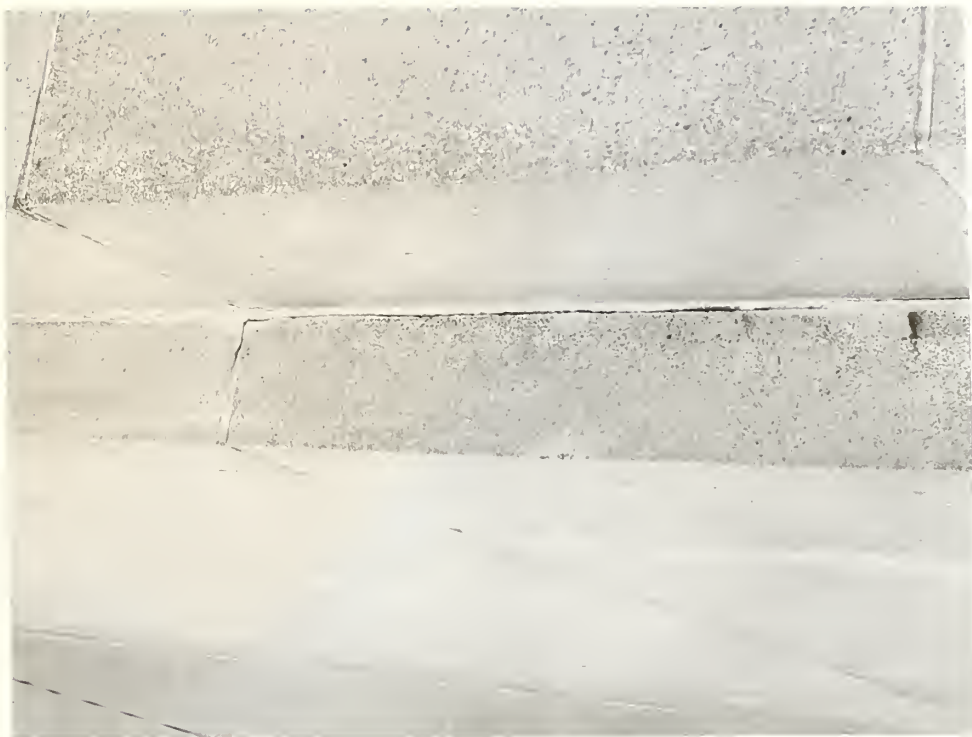
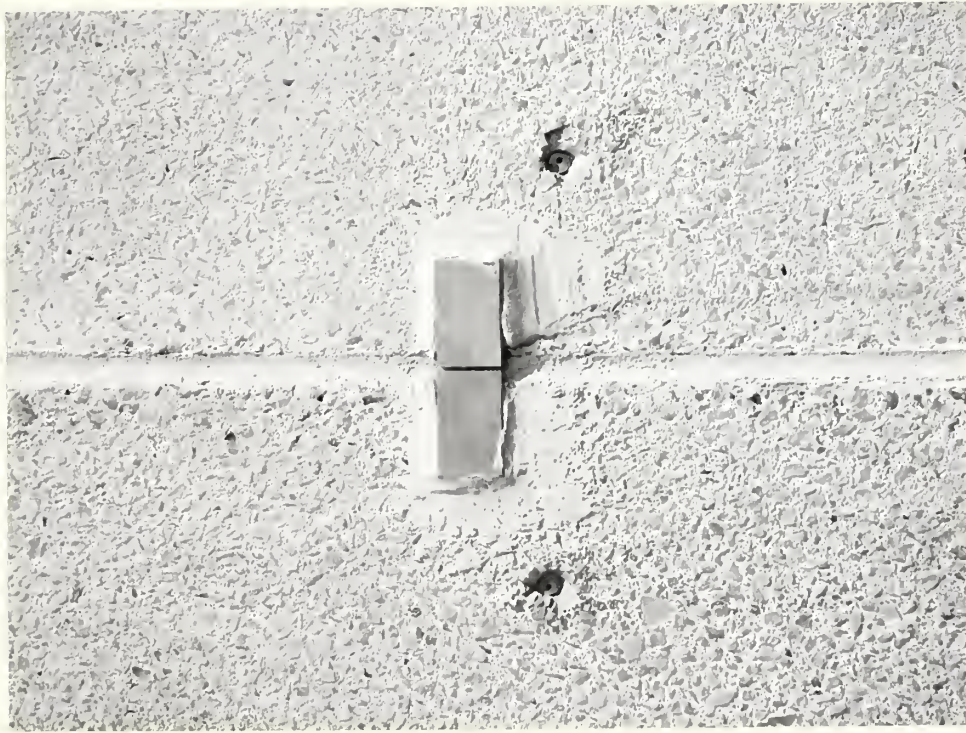
Although the authors have been informed by a representative of the maintenance department of the Medical Center that there has been no leakage of any consequence subsequent to the application of the waterproofing treatment, measurements made with the Whittemore gage indicated joint movements, which averaged 0.0066 in. for all four sides of the building, excluding the corner joints (chapter 5). Figure 18-A illustrates a corner joint (southeast) as it appeared the day before the waterproofing treatment was applied and figure 18-B shows the same corner as it appeared on April 22 approximately 7 months after the treatment.

Fig. 18. Illustration of a corner vertical joint on the southeast side, (19th floor, Building No. 1).
(A) Just before waterproofing treatment.
(B) As it appeared 7 months after treatment.
